Courtyard Pittsburgh University Center

Exterior Design | November 13, 2023

Re-concept the building exterior. Develop a custom design concept inspired by the Courtyard's current generation exterior architectural features, materials, and color palette. Retain and clean existing brick. Provide accent element at main entrance and adjacent to patio to mark hotel arrival from street. Integrate patio shade structure with overall exterior scheme.

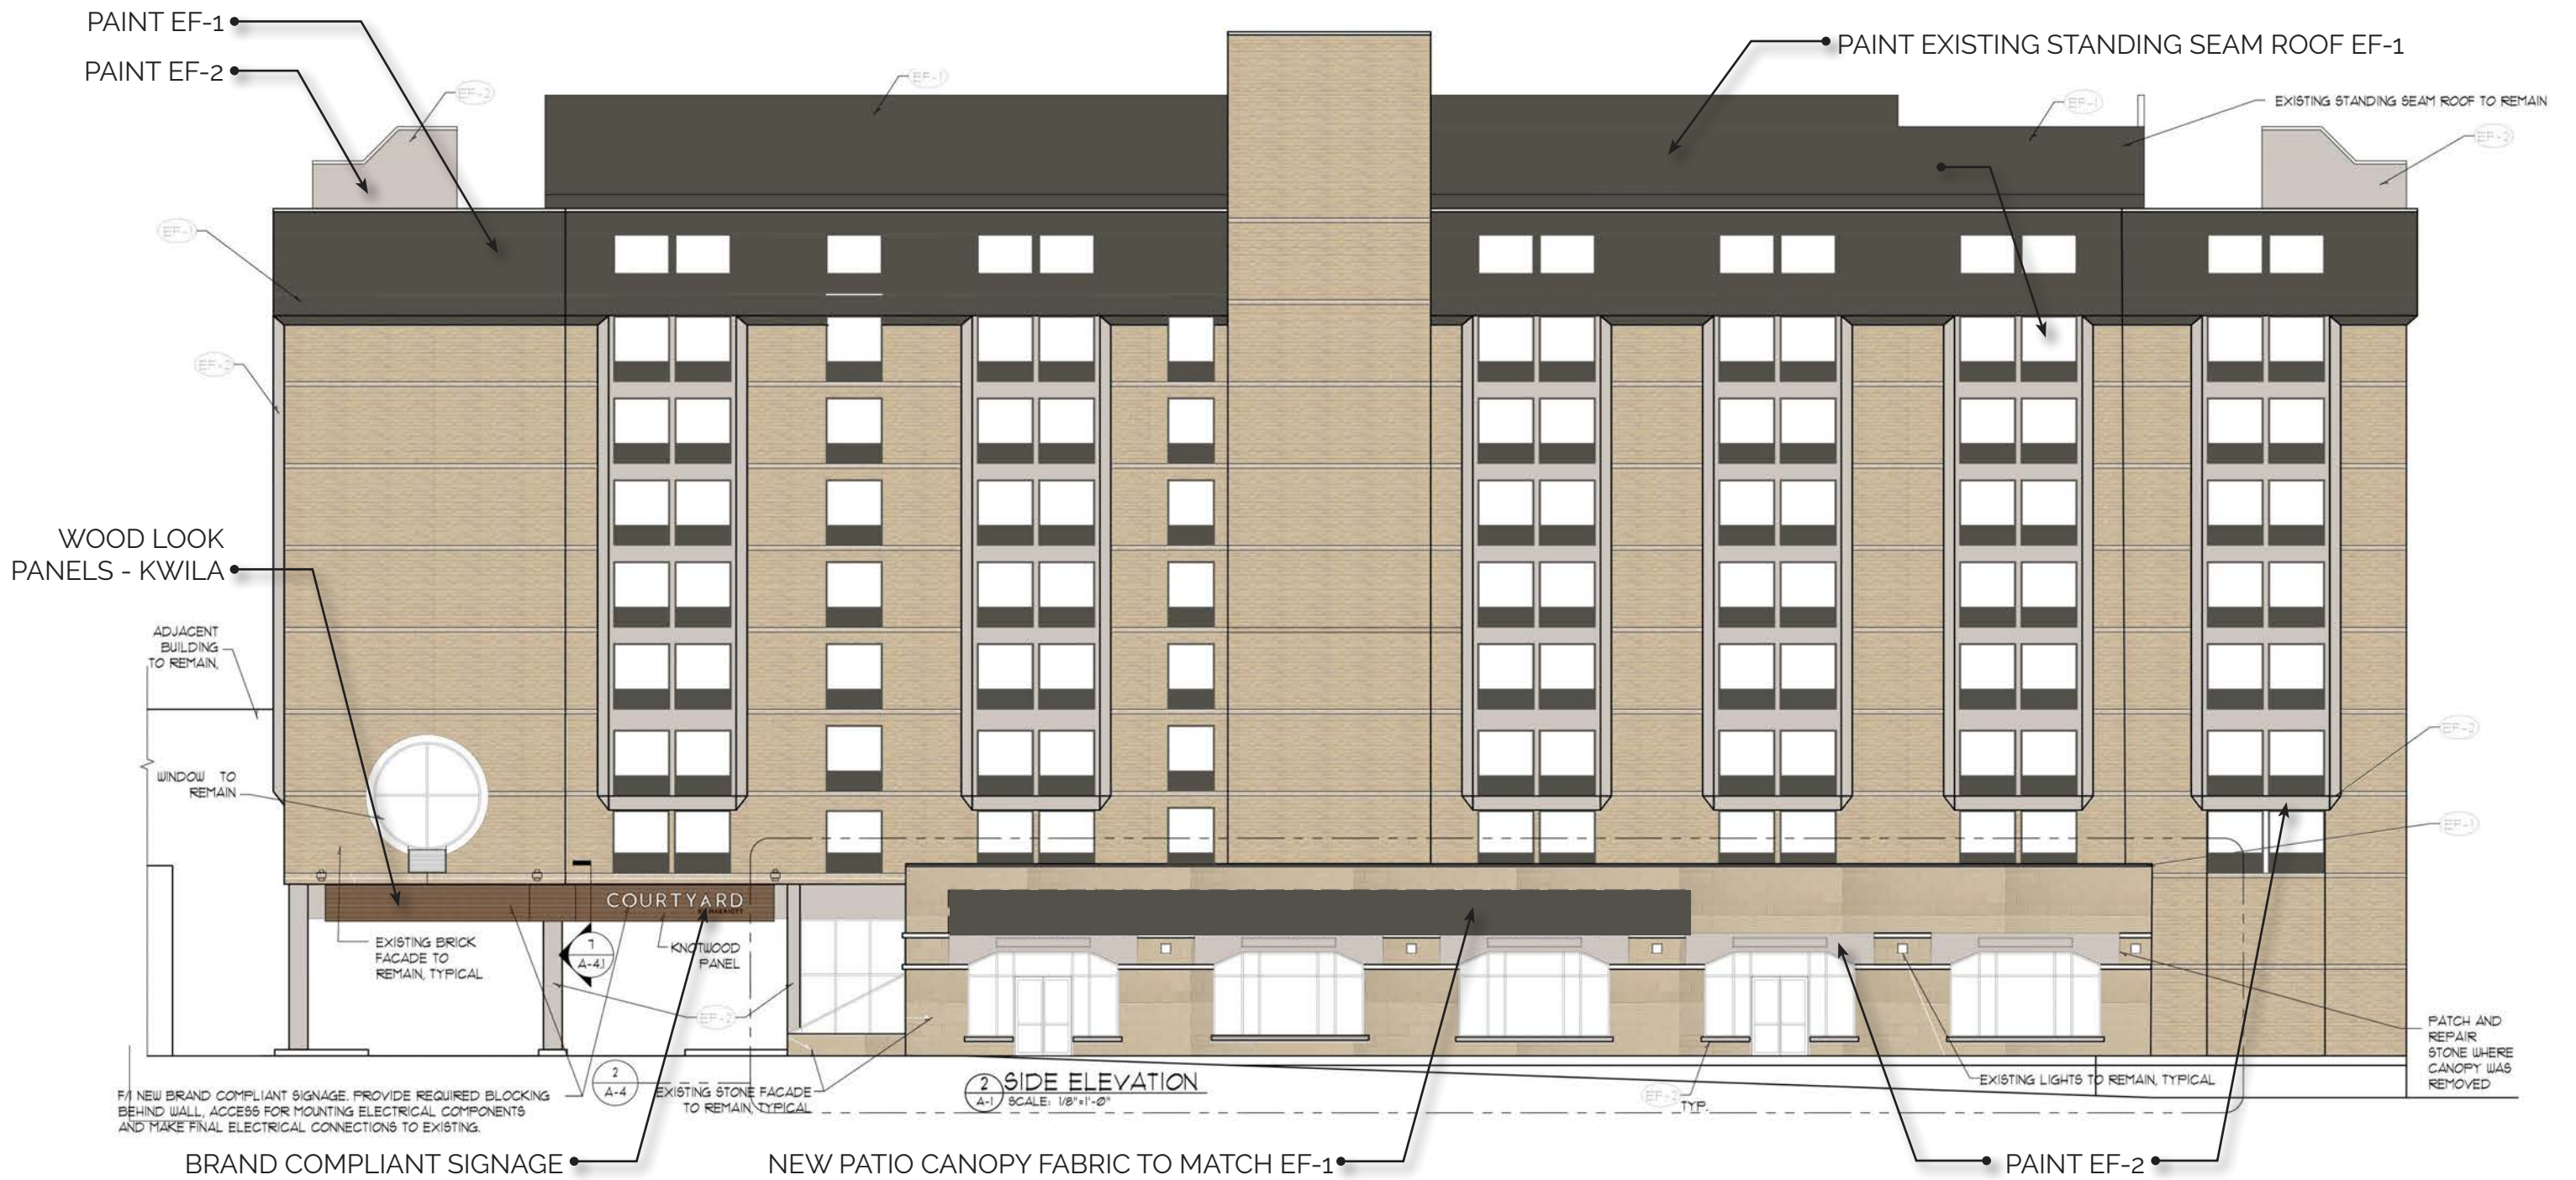
PRIMARY ELEVATION / MAIN ENTRANCE / SOUTHWEST

PAINT EF-1
SW 7048 URBANE BRONZE

PAINT EF-2
SW 7022 ALPACA

EXISTING BRICK TO REMAIN

EXISTING BLOCK TO REMAIN

KNOTWOOD WOOD-LOOK
PANELS - KWILA

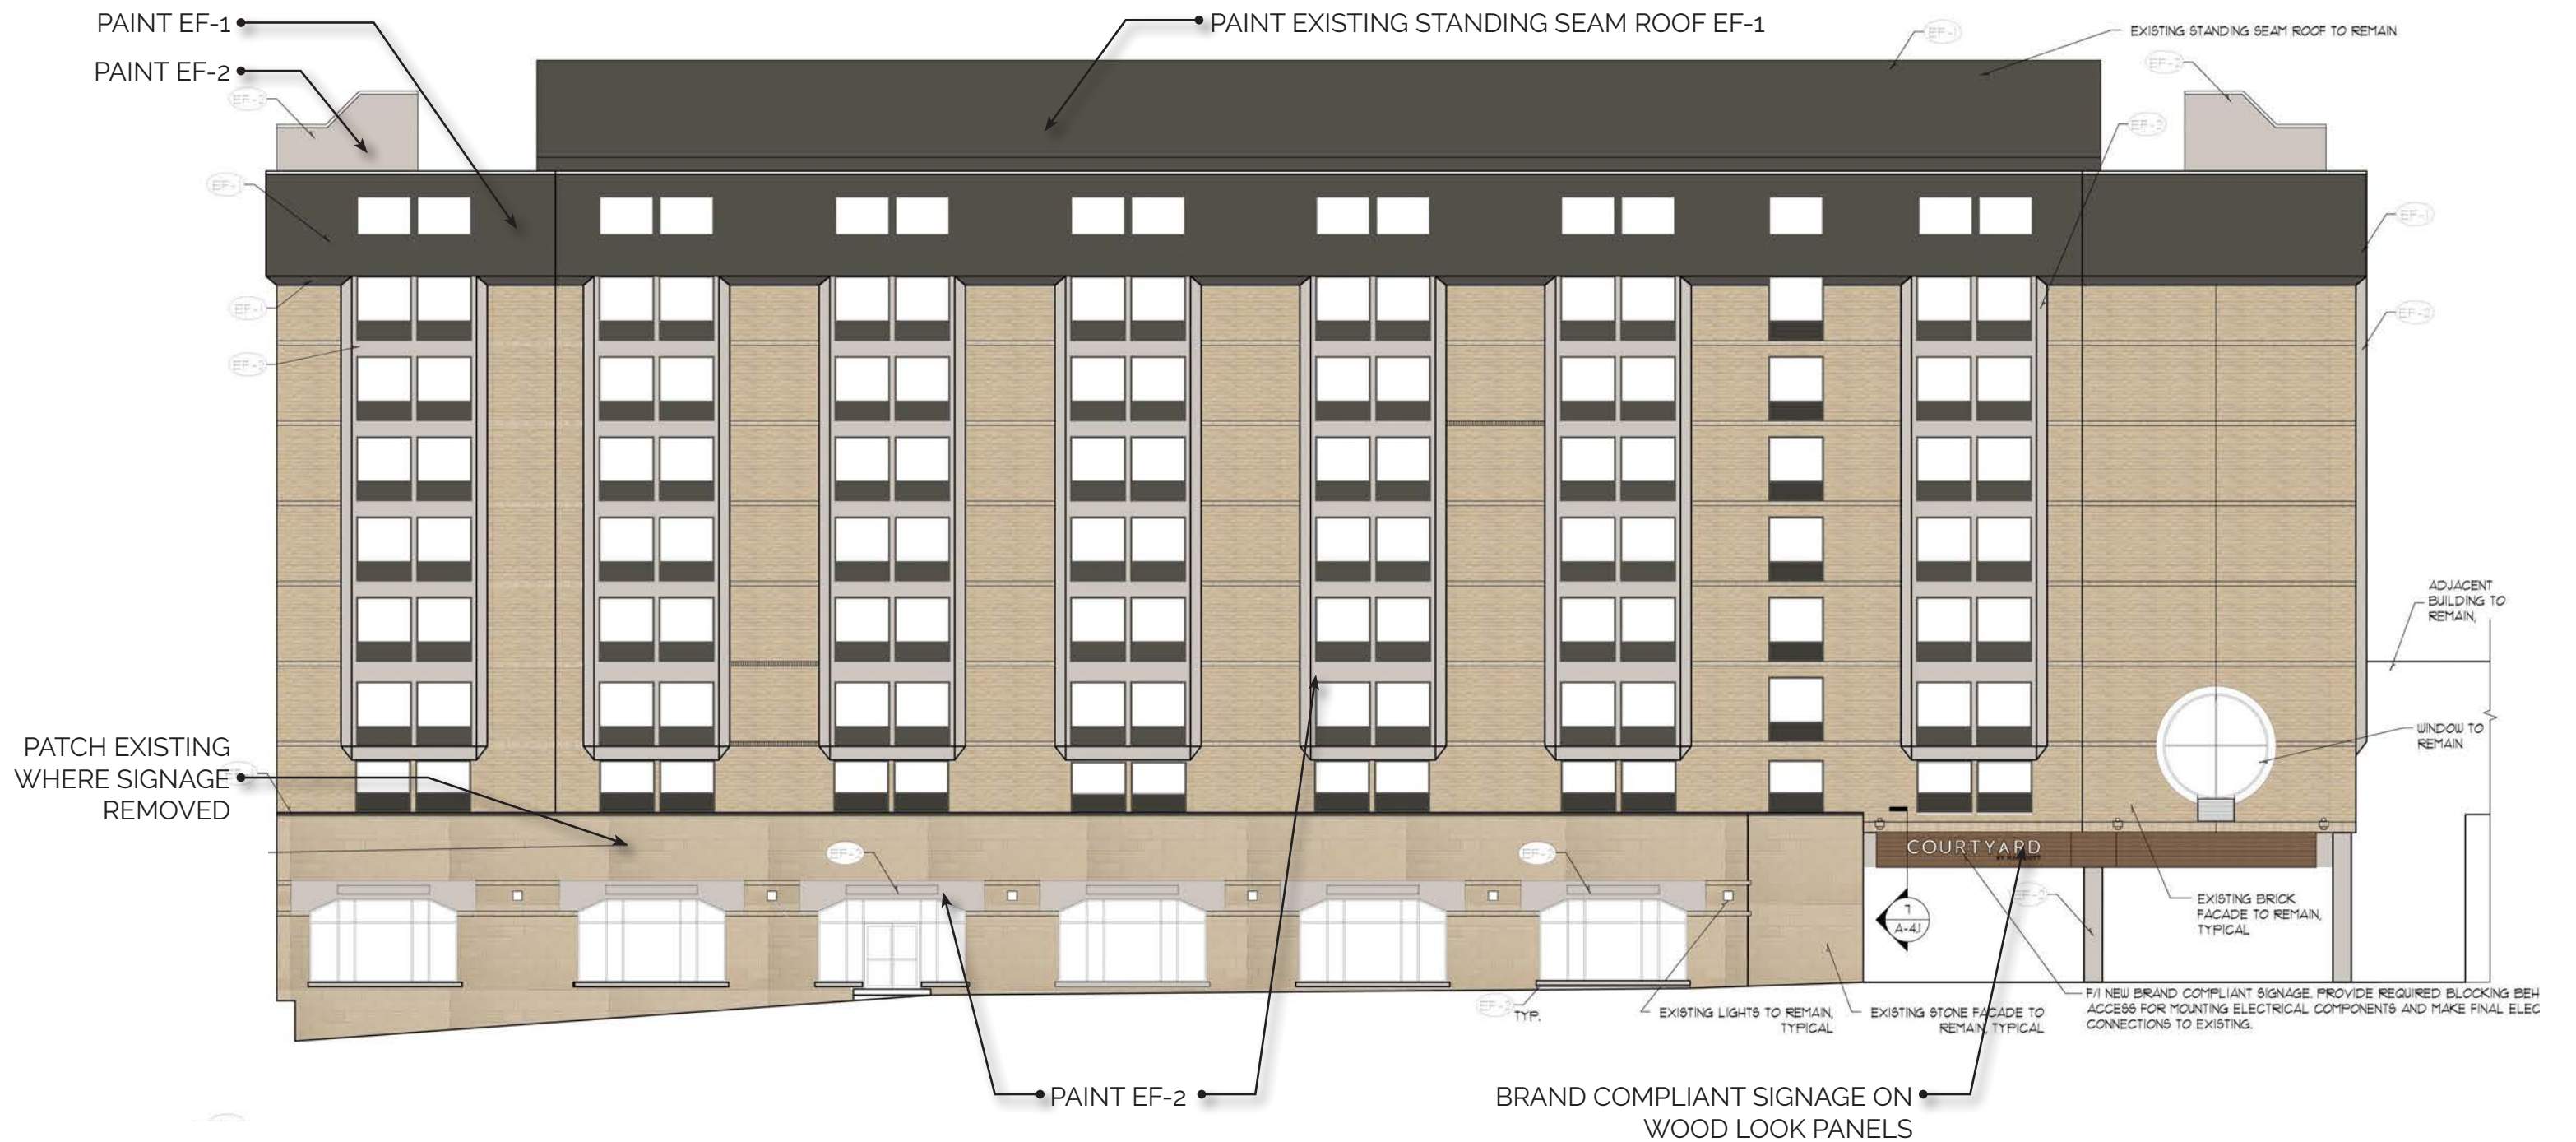
NORTHEAST ELEVATION

PAINT EF-1
SW 7048 URBANE BRONZE

PAINT EF-2
SW 7022 ALPACA

EXISTING BRICK TO REMAIN

EXISTING BLOCK TO REMAIN

KNOTWOOD WOOD-LOOK
PANELS - KWILA

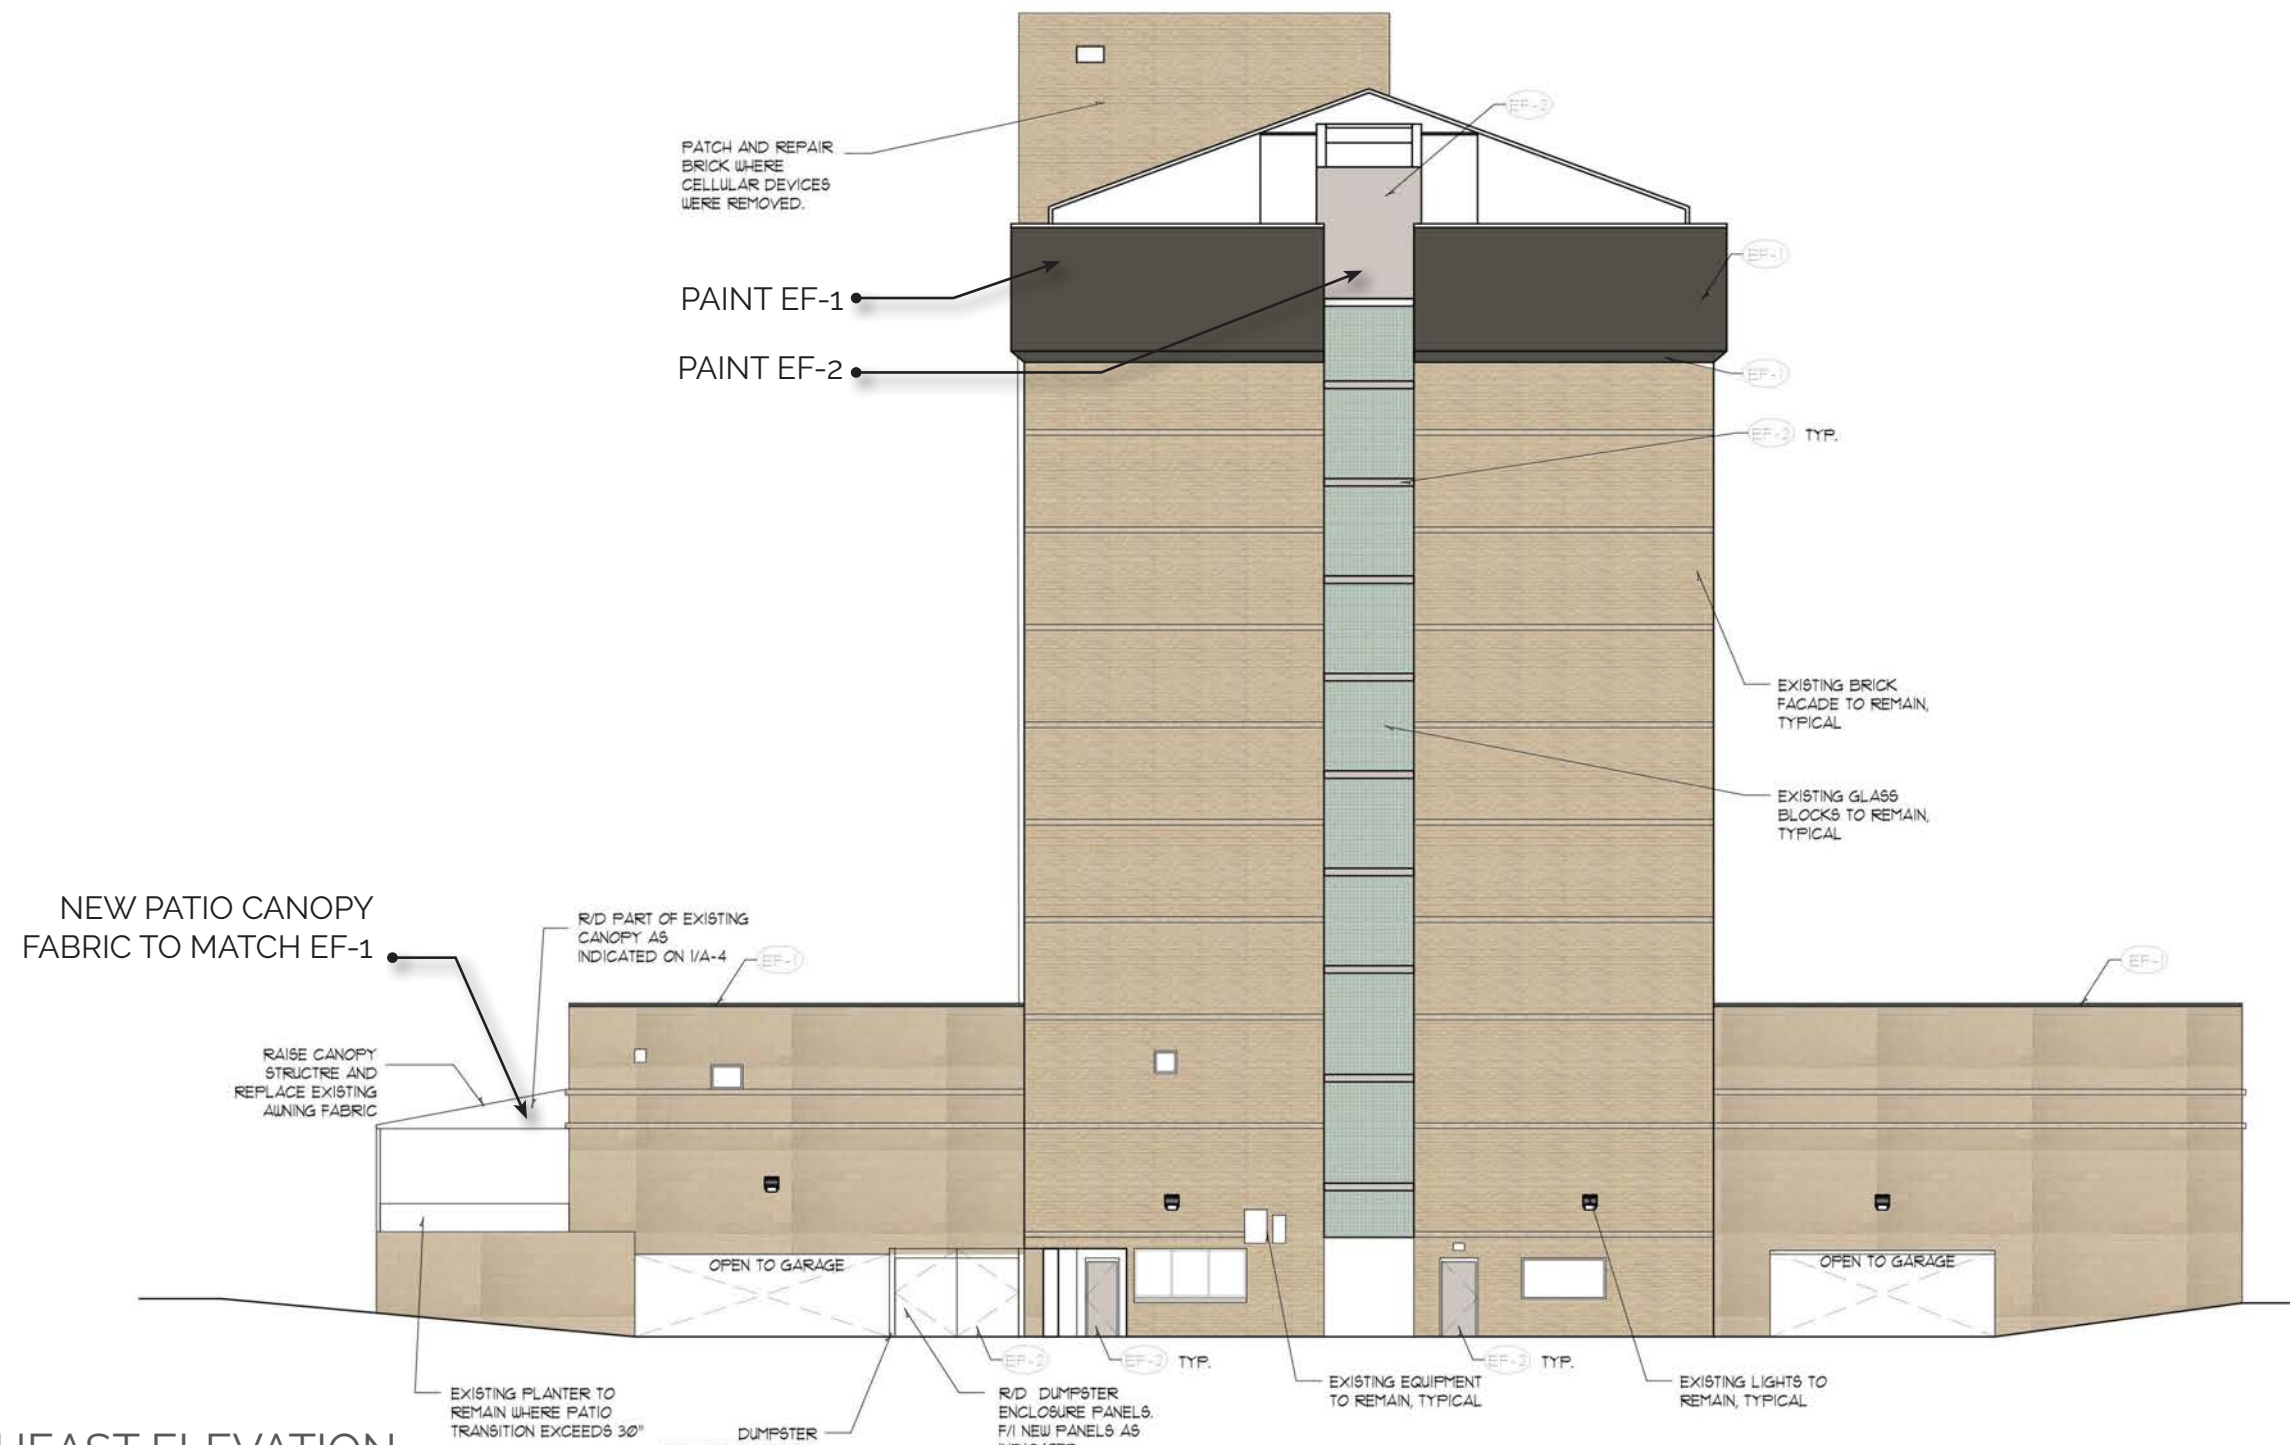
SOUTHEAST ELEVATION

PAINT EF-1
SW 7048 URBANE BRONZE

PAINT EF-2
SW 7022 ALPACA

EXISTING BRICK TO REMAIN

EXISTING BLOCK TO REMAIN

KNOTWOOD WOOD-LOOK
PANELS - KWILA

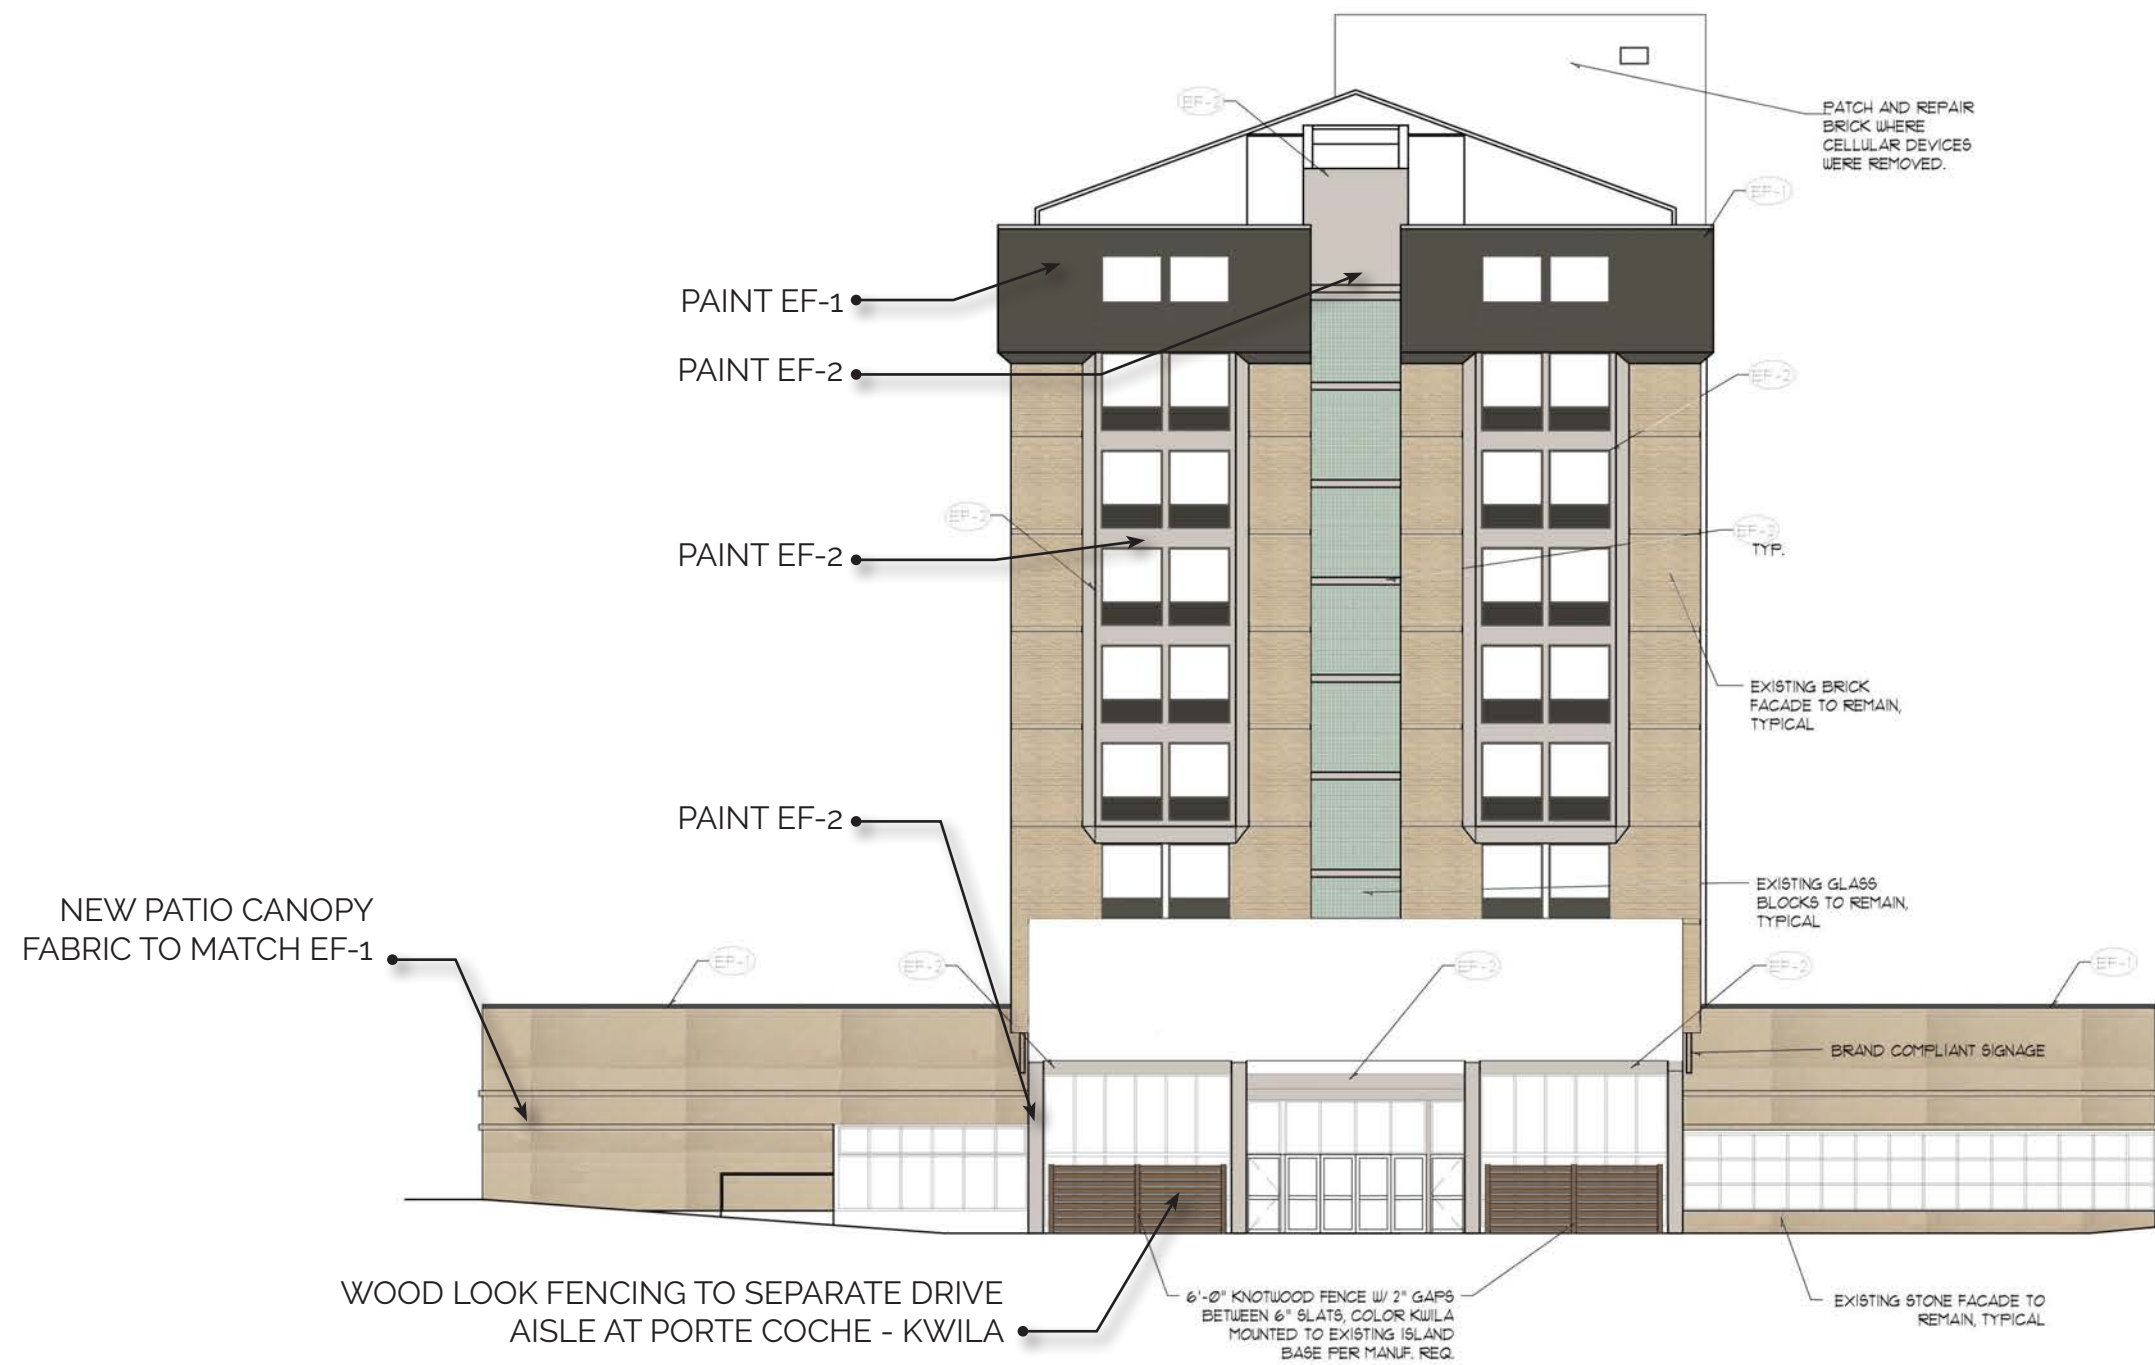
NORTHWEST ELEVATION

PAINT EF-1
SW 7048 URBANE BRONZE

PAINT EF-2
SW 7022 ALPACA

EXISTING BRICK TO REMAIN

EXISTING BLOCK TO REMAIN

KNOTWOOD WOOD-LOOK
PANELS - KWILA
